Manhole Inspection Summary

Manhole # S53K__060MH

Insp Date: **9/14/09 10:41 AM**

Location Address: **behind 642 Ellwood Ave.**

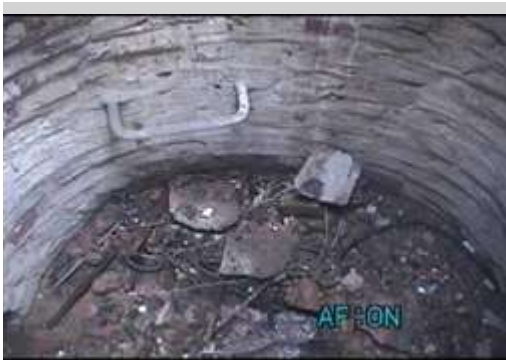
Miscellaneous

debris at the base

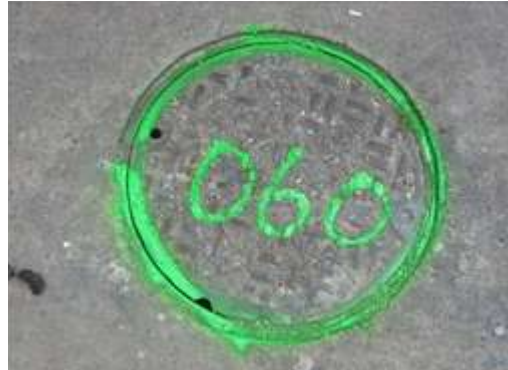
Miscellaneous

MH Lid

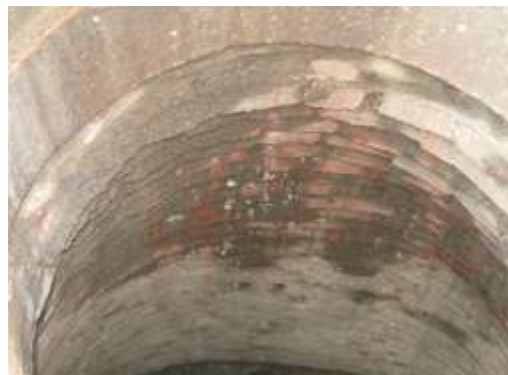
Defect 4

Corbel Material: **Brick** ☐ Parged Type: **Concentric/Eccentric**

Infiltration: ☐ None ☐ Joint ☐ Cracks ☒ **Mortar** ☐ Roots ☐ Wall

corbel infiltration at mortar

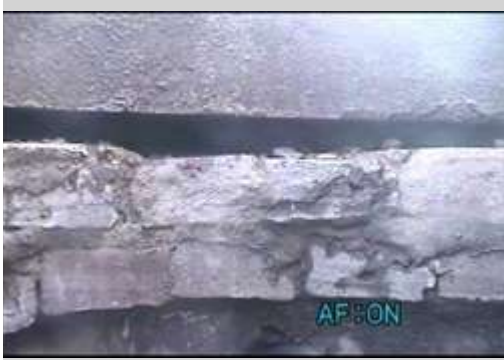
Defect 1

Chimney / Frame Adjustment ☒ Exists Material: **Brick** ☐ Parged Height: **7** (in.)

Condition: ☐ Sound ☐ Cracked ☐ Root Intrusion ☐ Loose Brick ☒ **Deteriorated**

Infiltration: ☐ None ☒ **Joint** ☐ Cracks ☐ Mortar ☐ Roots ☐ Wall

deteriorated chimney with infiltration from joint

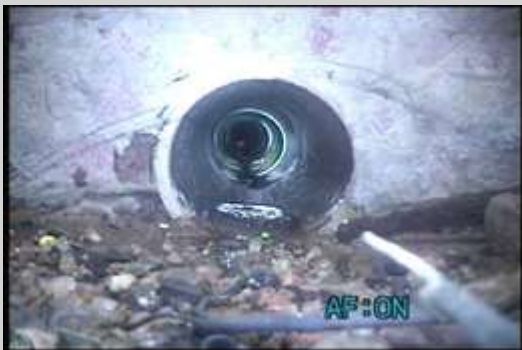
12 O'Clock Outflow

8 in. Circular Gravity Sewer
Pipe Out @ 12 O'Clock
